Manhole Inspection Summary

Manhole # S170__014MH

Insp Date: **3/7/08 10:59 AM**

Location Address: **2558 wilkens-alley-christian**

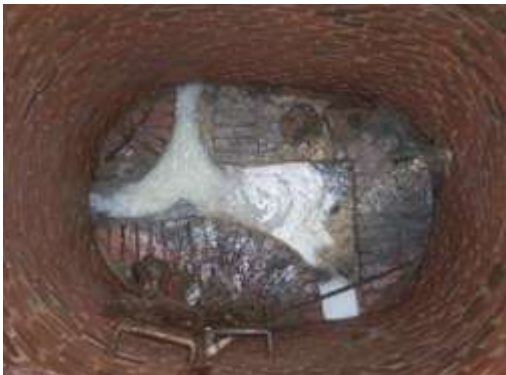
Condition: ☒ Sound ☐ Cracked ☐ Root Intrusion ☐ Deteriorated ☐ Leaks ☐ Debris

bench debris

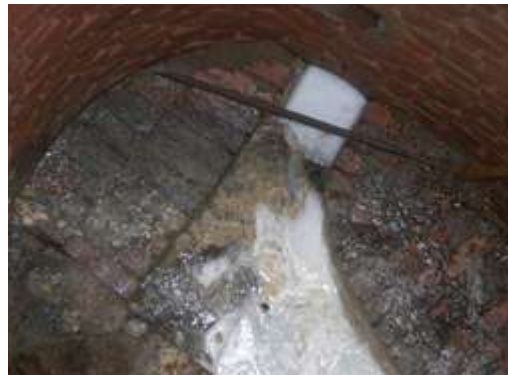
Defect 2

Condition: ☐ Sound ☐ Cracked ☐ Root Intrusion ☐ Deteriorated ☐ Leaks ☒ **Debris**

debris in the channel

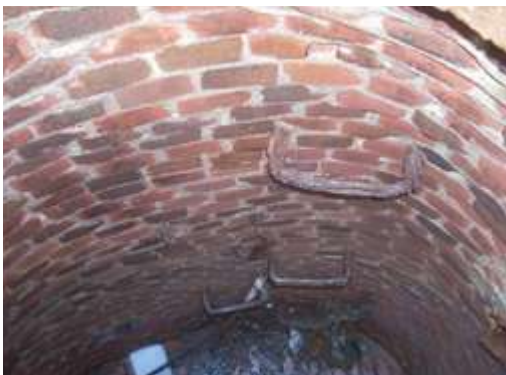
Defect 1

Count: **4** Missing: **2** ☒ **Corroded**

corroded and missing steps

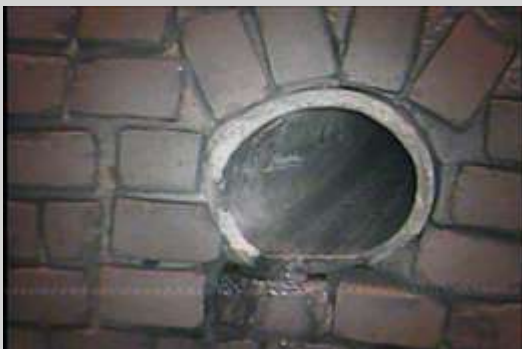
3 O'Clock Inflow

Pipe Height: **6** (in.) Rod and Bar (Angled)
Pipe Material: **Clay** ☐ Pipe Lined
Invert Depth: **8.47** (ft.) Flow Characteristics: **None**
Deposits: ☒ None ☐ Mud ☐ Sludge ☐ Debris ☐ Grease
Silt Depth: **0** (in.) Deposits Extent:
Infiltration: **None** Pipe Seal Cond: **Broken**

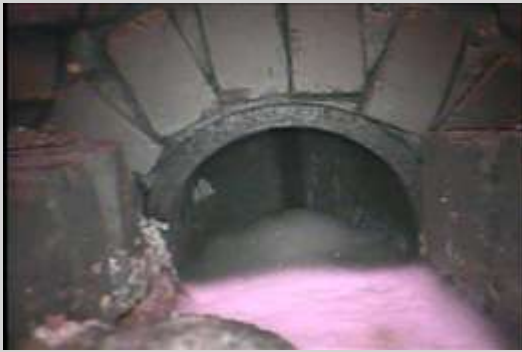
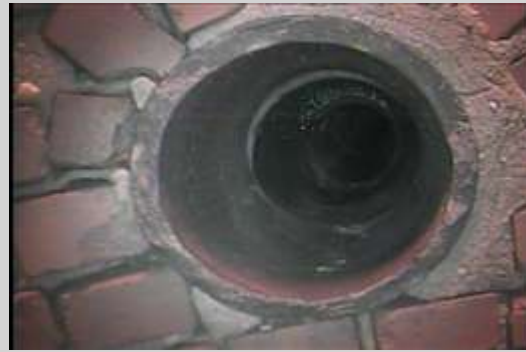
6 O'Clock Inflow

Infiltration: **None** Pipe Seal Cond: **Broken**

Drop: **Outside** Rod and Bar
Angled: **Yes** Reading: **9.19** (ft.)
Inv Depth: **10.19** (ft.)
Drop Condition: **Open**

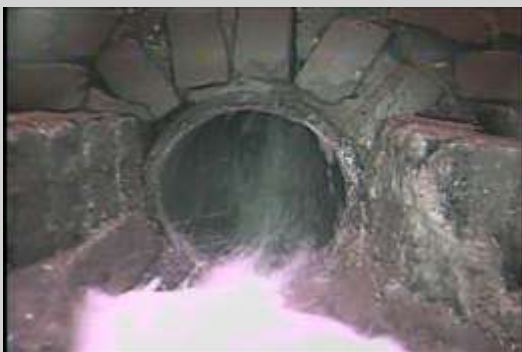
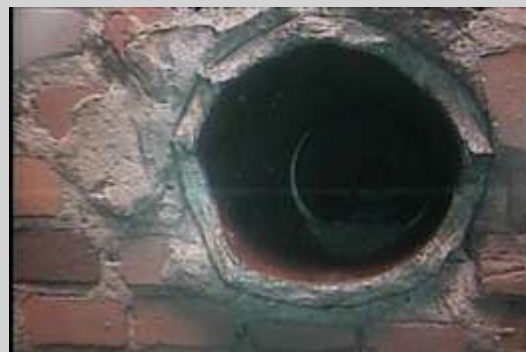
9 O'Clock Inflow

Infiltration: **None** Pipe Seal Cond: **Broken**

Drop: **Outside** Rod and Bar
Angled: **Yes** Reading: **9.12** (ft.)
Inv Depth: **10.12** (ft.)
Drop Condition: **Open**
